NIST Special Publication 901

The January 17, 1995 Hyogoken-Nanbu (Kobe) Earthquake

*Performance of Structures, Lifelines, and Fire
Protection Systems*

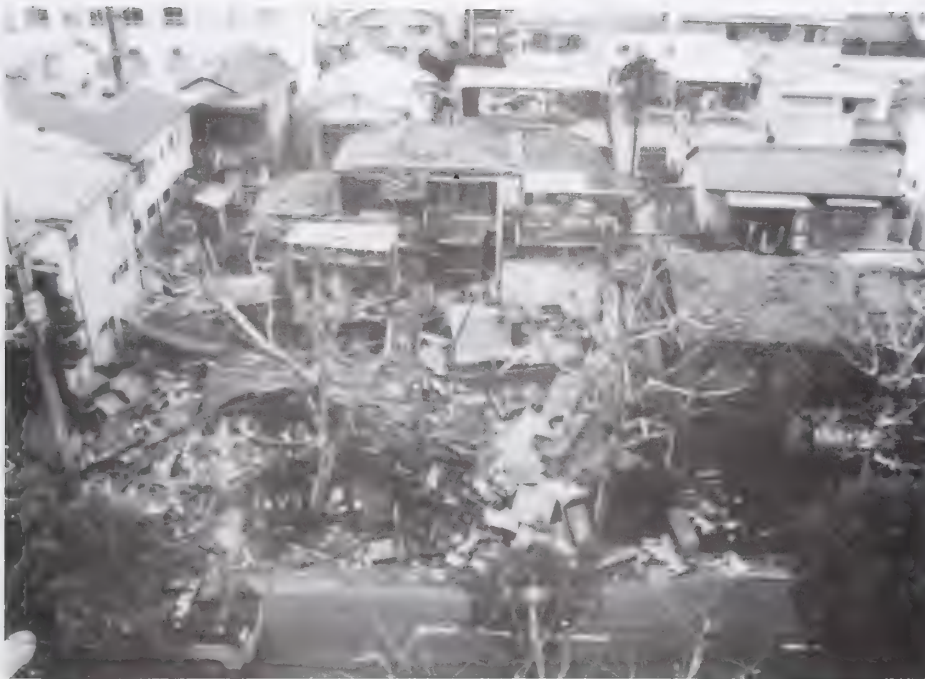
For fire to spread by flame impingement, the flames must be in contact with unburned fuel, i.e., the fire can only spread along a continuous fuel chain. In the earthquake damaged areas continuous fuel chains were prevalent. Rubblized structures are a good

Figure 6.2.9 Collapsed houses. Notice that the pile of debris is in contact with the adjacent houses, forming a continuous fuel chain.

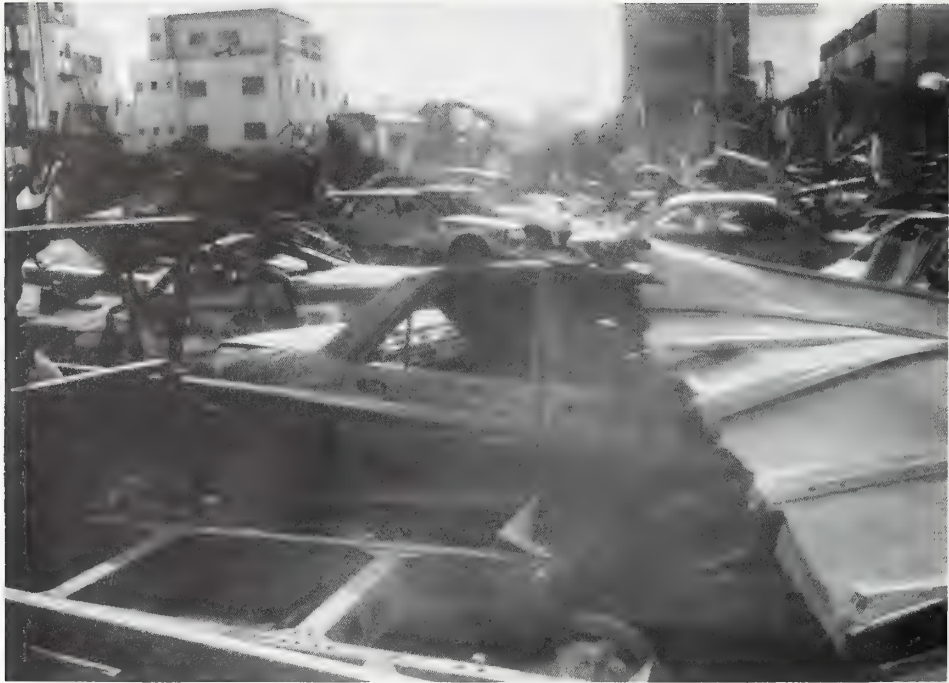
Automobiles were identified by Murosaki [5] as a mechanism for fire spread. Burnt automobiles were seen in narrow alleys between burnt structures. The automobiles, serving as a source of fuel, spread fire from one building to the other. Parking areas with burnt cars were also observed (Figure 6.2.11). Without the fuel provided by the autos, the parking areas would have acted as fire breaks (Figure 6.2.12).

Figure 6.2.11 Parking area where automobiles contributed to fire spread between buildings.

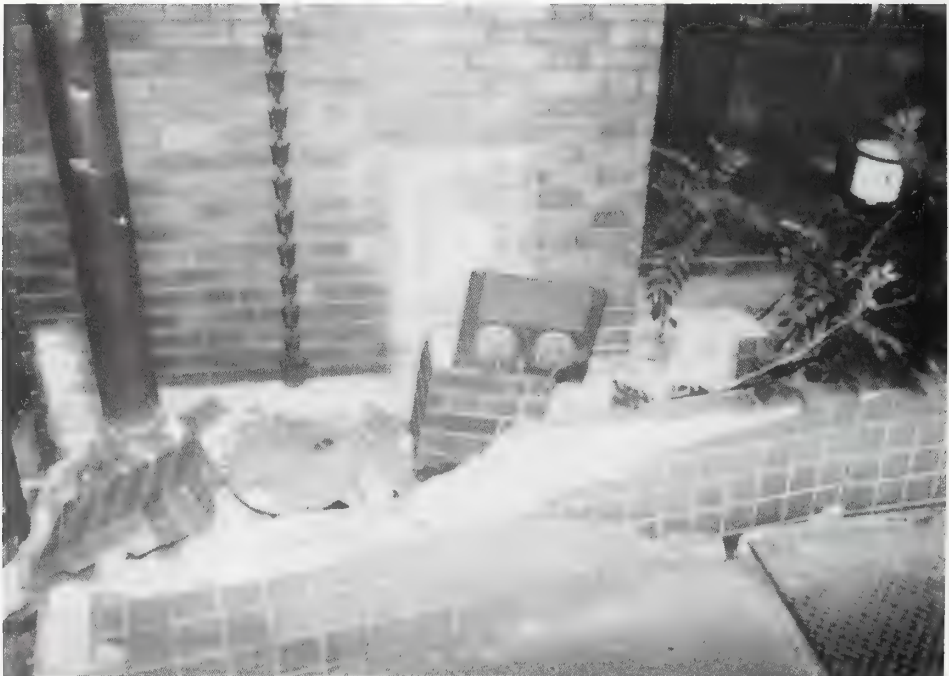
Active building systems were not a factor in mitigating the fires during this disaster. No active systems were present in the residential fire areas and only hose stations and stand pipes were observed in the burned out industrial/commercial areas. A few hose station systems had self contained water supplies, however the majority of suppression systems were rendered useless by a lack of water due to the broken supply piping. Even if the fire department could have supplied water to the standpipe systems of a building, many standpipe connections which had broken free of the building system were observed (Figure 6.2.12).

Figure 6.2.12 Standpipe connection severed at street level.

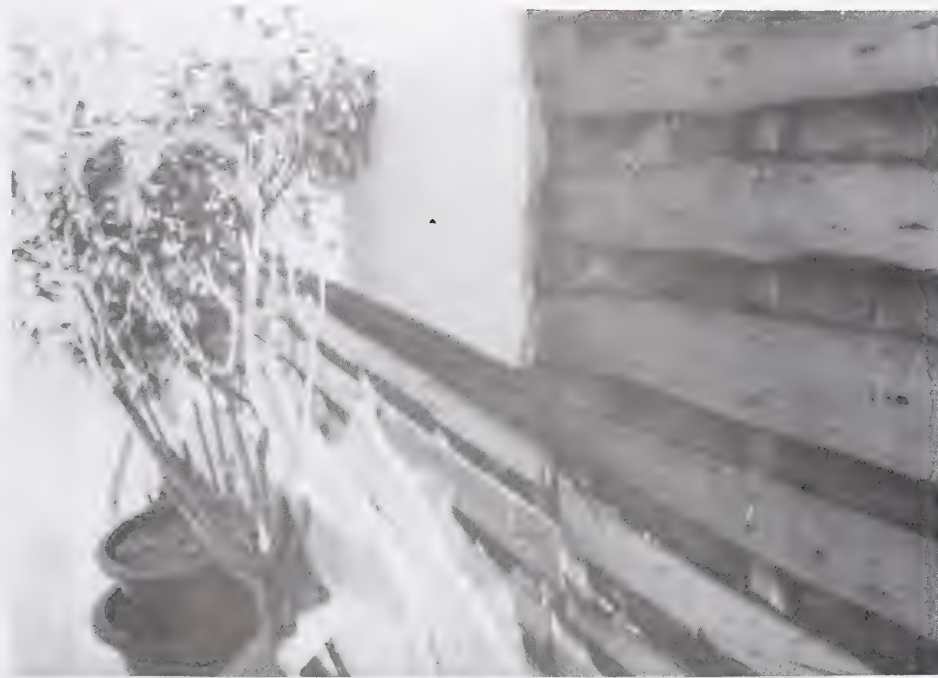
Figure 6.2.13 Example of okabe construction with portions of the fire resistive mortar displaced by the earthquake.

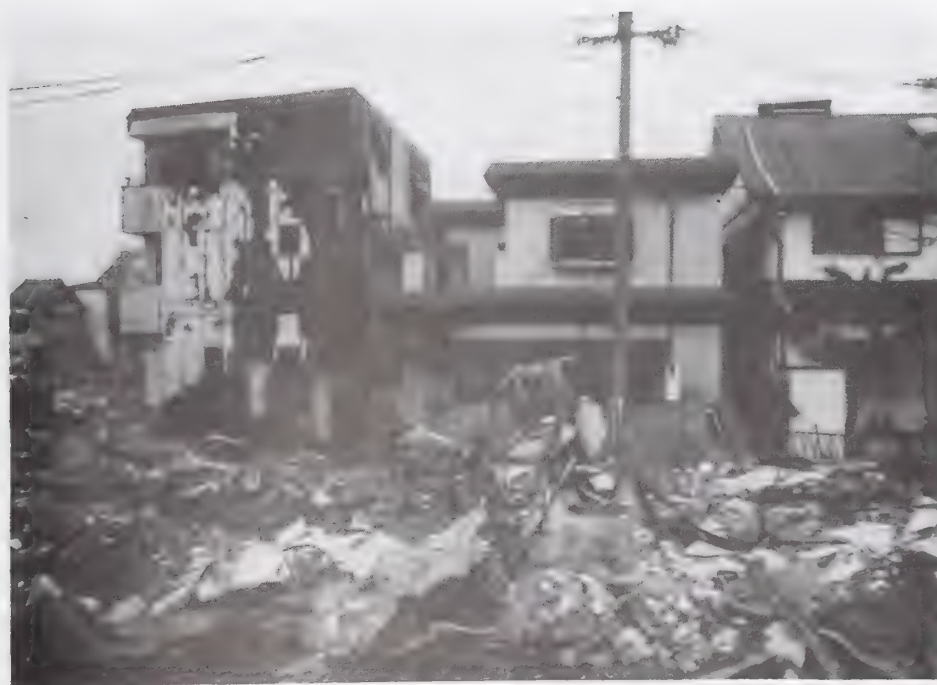
Figure 6.2.18 Burned out structure constructed from fire resistive materials.

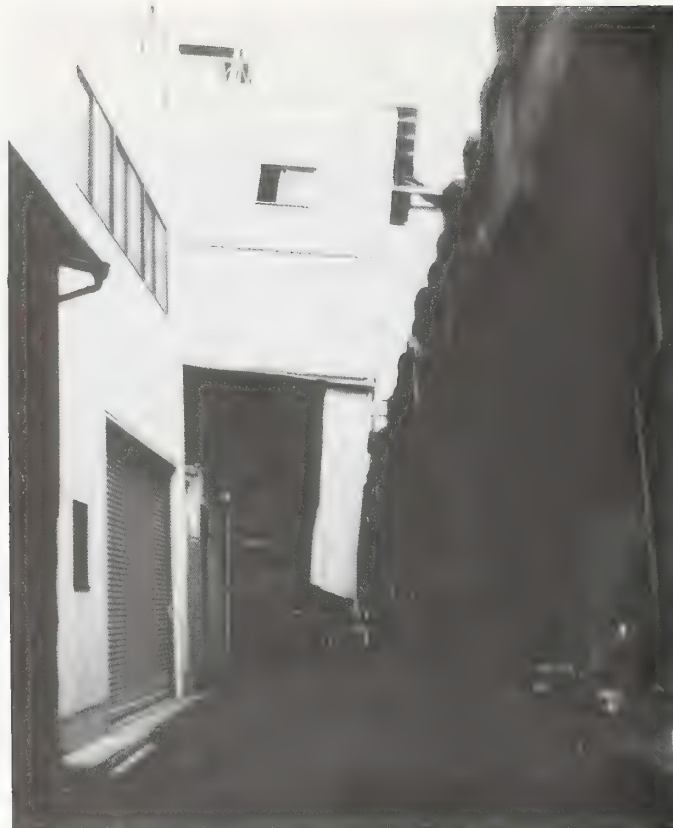
Figure 6.2.23 Road blocked by three story building.

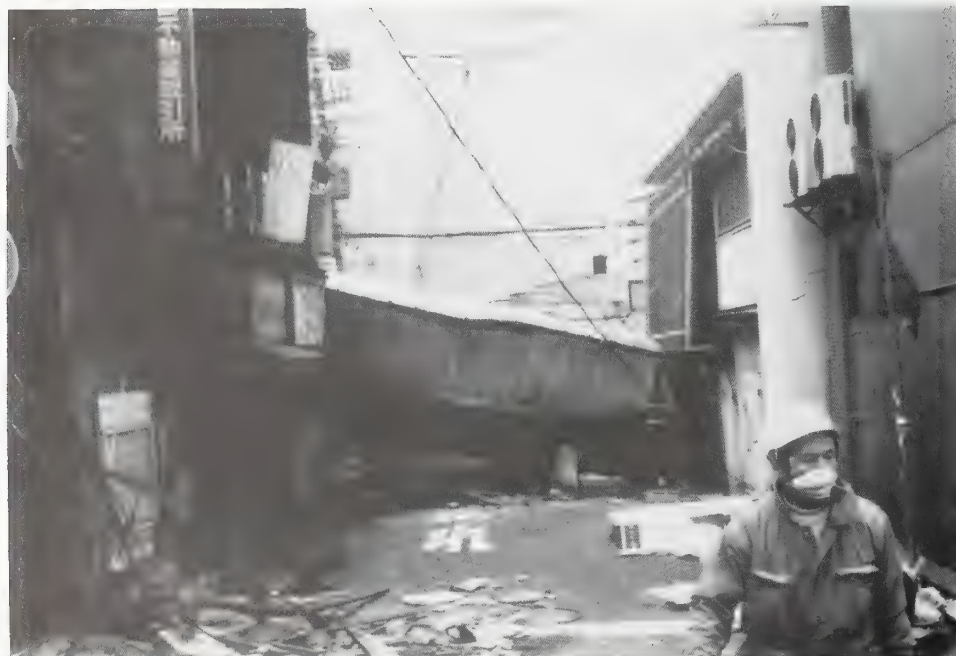
Figure 6.2.24 Road blocked by collapsed structure.

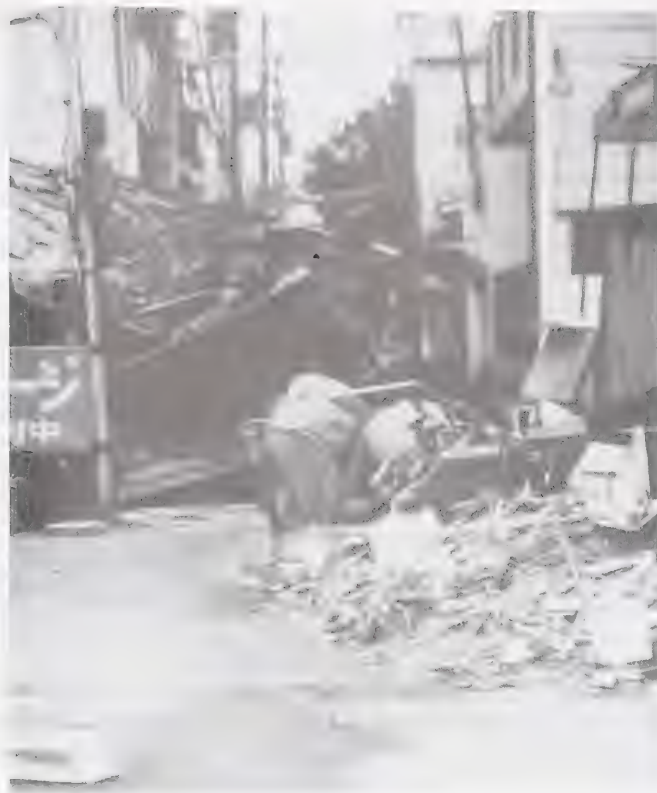
Figure 6.2.25 Road blocked by collapsed structure.

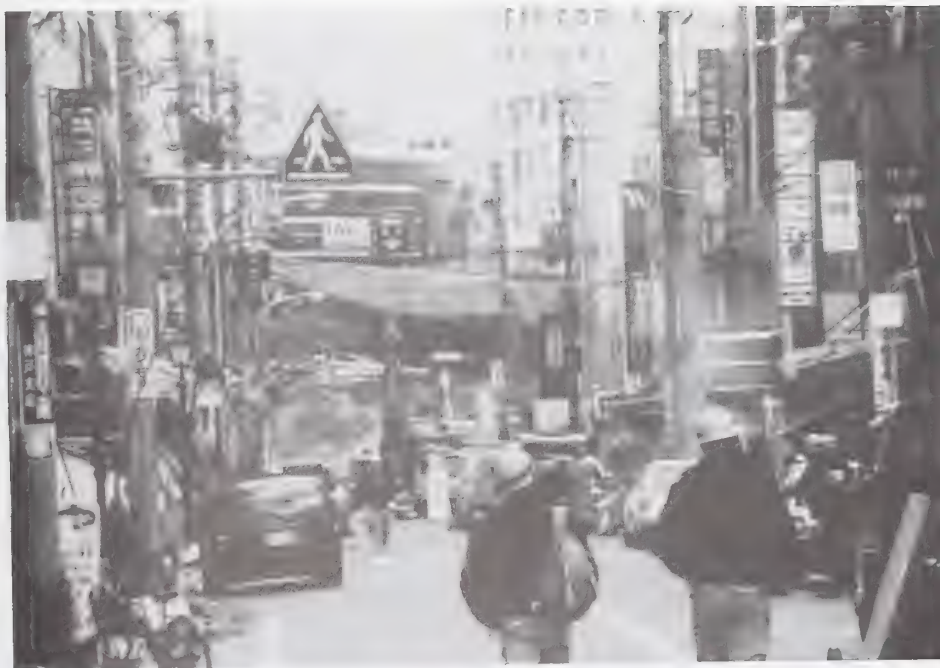
Figure 6.2.26 Collapsed train overpasses such as this one divided Kobe north and south.

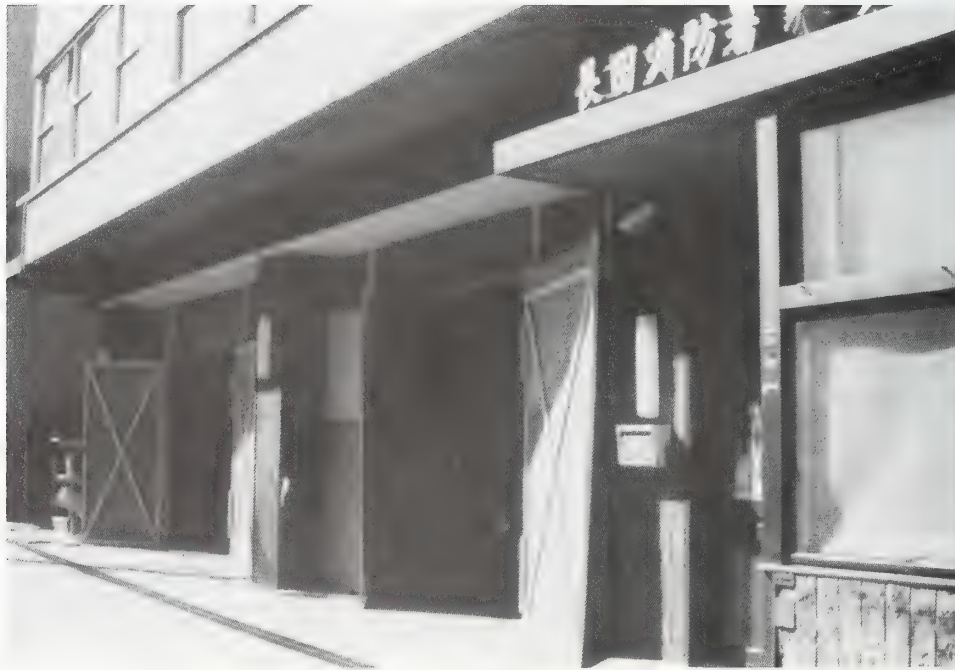
Figure 6.2.28 Fire station damaged by the earthquake.
